RE: Virginia Power – Possum Point Power Station –VA0002071

Recon Inspection Report – Coal Fly Ash Impoundments

FACILITY NAME: Dominion Possum Point Power Station		INSPECTION DATE: 05-13-09 INSPECTOR: Wilamena Harback Joseph Trocchio	
PERMIT No.: VA0002071		REPORT DATE: 05-27-09	
TYPE OF FACILITY: <input type="checkbox"/> Municipal <input checked="" type="checkbox"/> Major <input checked="" type="checkbox"/> Industrial <input checked="" type="checkbox"/> Minor <input type="checkbox"/> Federal <input type="checkbox"/> Small Minor		TIME OF INSPECTION: <div style="display: flex; justify-content: space-between;"> <div style="text-align: center;"> Arrival 0830 </div> <div style="text-align: center;"> Departure 1205 </div> </div>	TOTAL TIME SPENT (including prep & travel): 16 hours
PHOTOGRAPHS: <input checked="" type="checkbox"/> Yes <input type="checkbox"/> No		UNANNOUNCED INSPECTION? <input type="checkbox"/> Yes <input checked="" type="checkbox"/> No	
REVIEWED BY / Date: <div style="text-align: center;"> 05-27-09 </div>

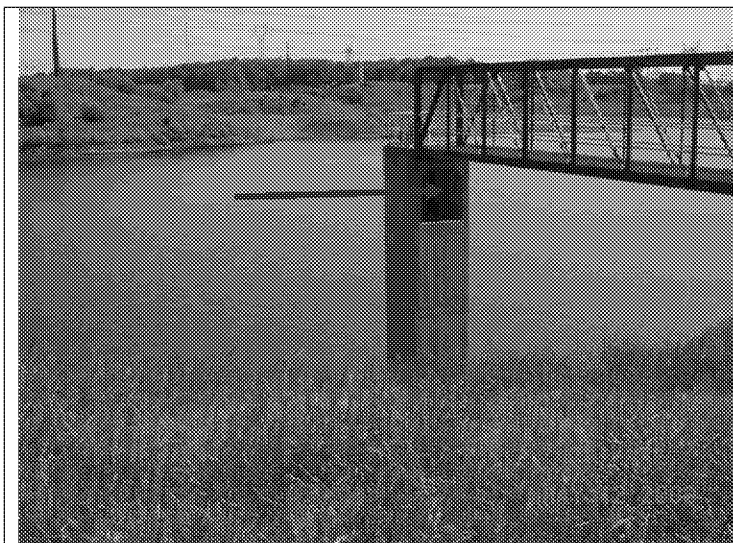
1) Ash Pond D at the outlet structure (red). Note the significant freeboard.

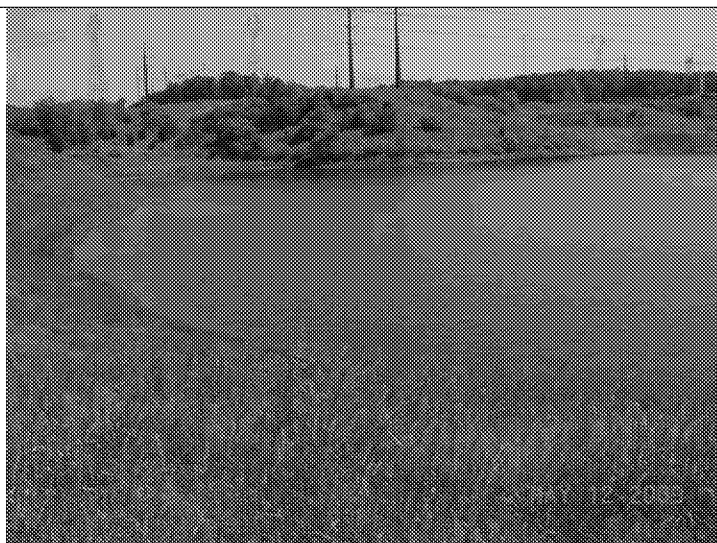
2) Different view of Ash Pond D (to the left of photo #1).

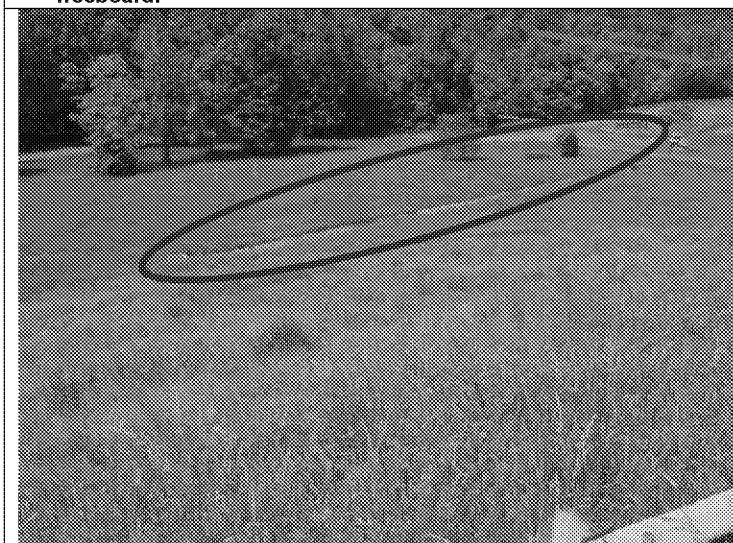
3) Outlet to Ash Pond D (red), concrete lined and discharges into Pond E (located in the direction of the blue arrow).

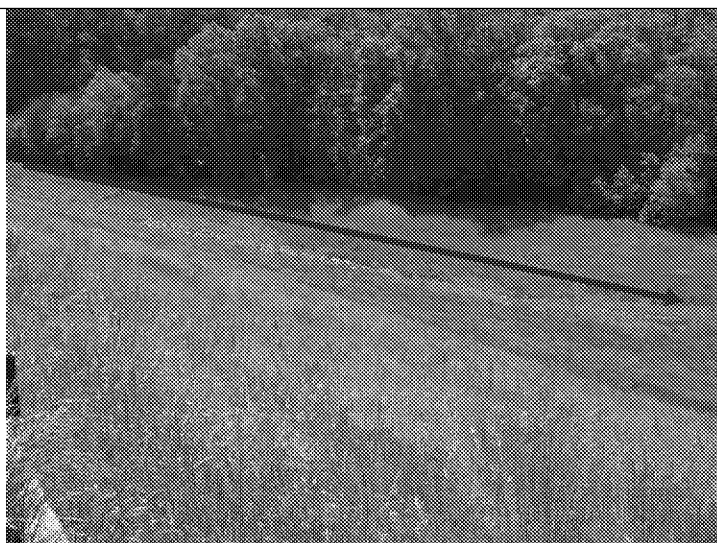
4) Emergency spillway (red) for Ash Pond D.

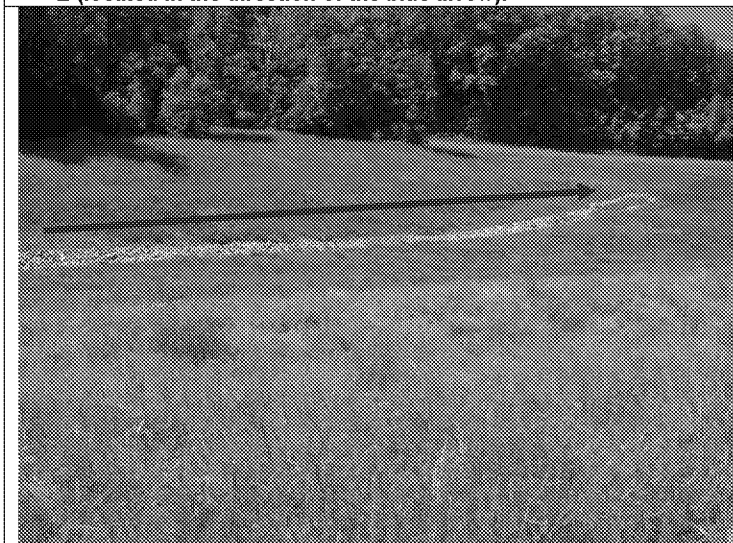
5) Continuation of photo #4, emergency spillway (red) continued for Ash Pond D.

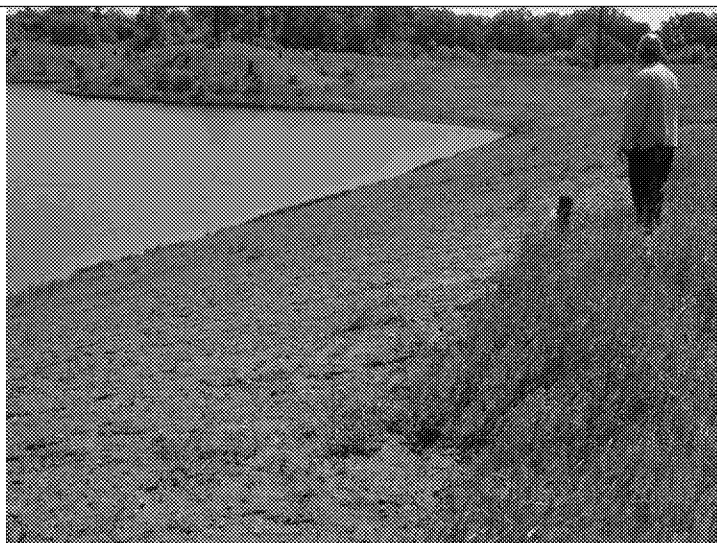
6) Area on Ash Pond D that was recently re-graded and re-seeded.

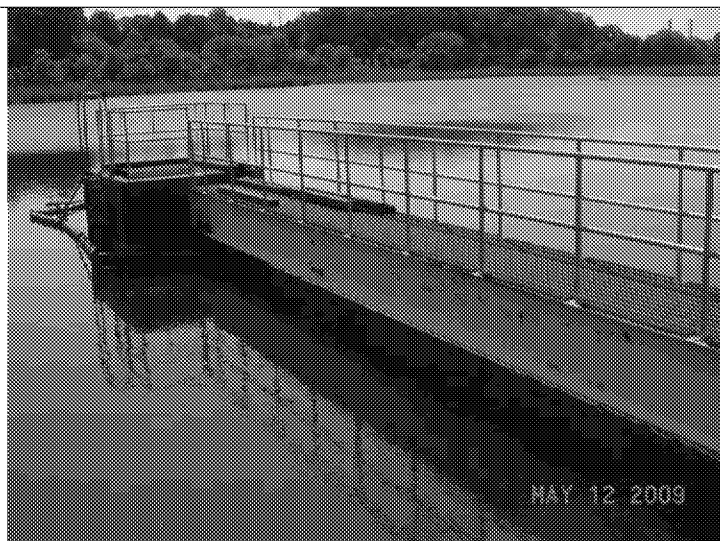
7) Ash Pond E at the principal outlet/spillway to Outfall 005.

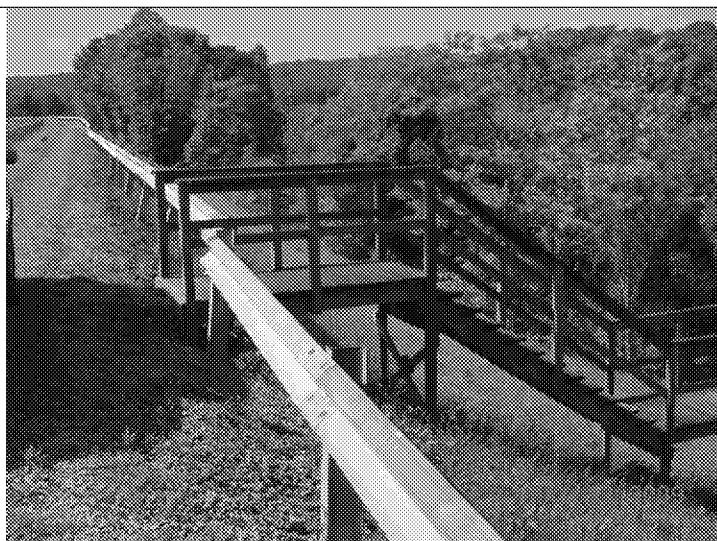
8) Stairs to Outfall 005 from Ash Pond E.

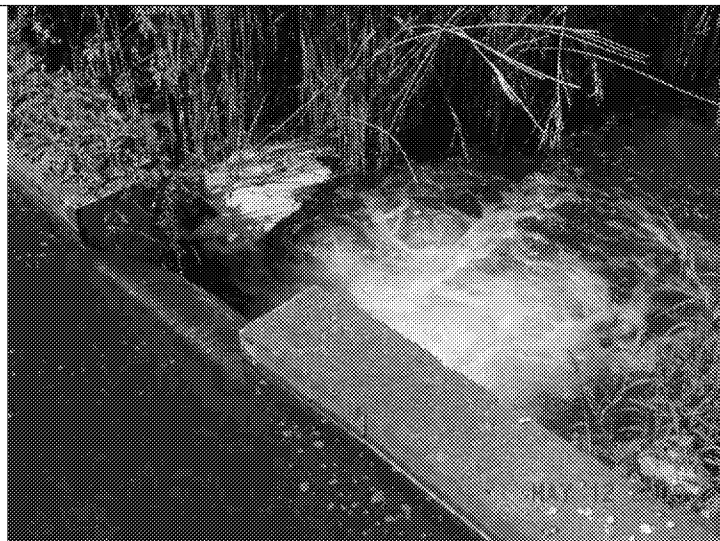
9) Outfall 005 from Ash Pond E.

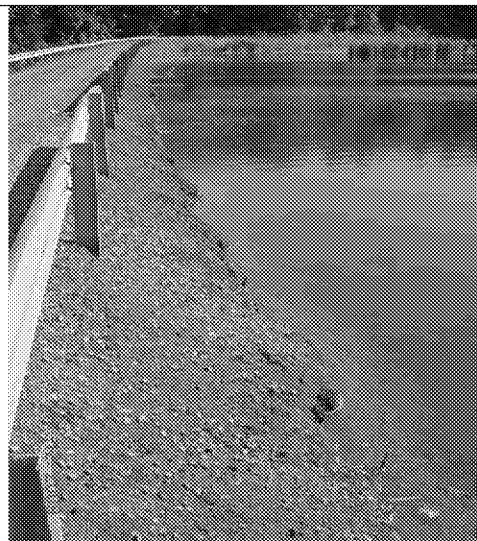
10) Ash Pond E with approximate freeboard.

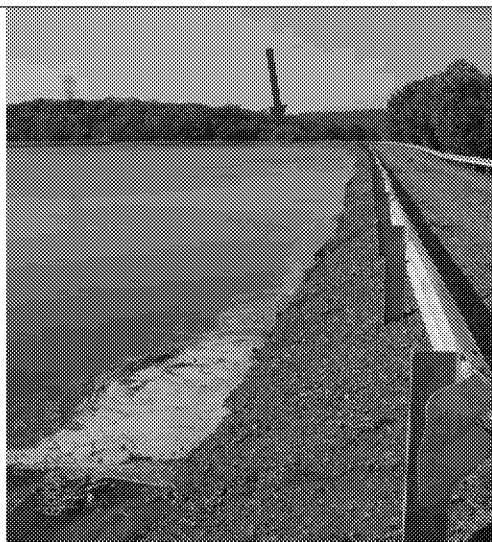
- The facility should evaluate the one section of Ash Pond E where there was some erosion on the inside of the berm. The railing along the side of the berm road is no longer secured in the ground and has shifted. (See attached photos.) This section was also mentioned in the most recent DCR inspection on 05-29-2008.

11) View of the Ash Pond E. The area with the erosion issue is at the red arrow.
